Manhole Inspection Summary

Manhole # S31A__007MH

Insp Date: **12/20/07 1:09 PM**

Location Address: **403 GEORGE ST**

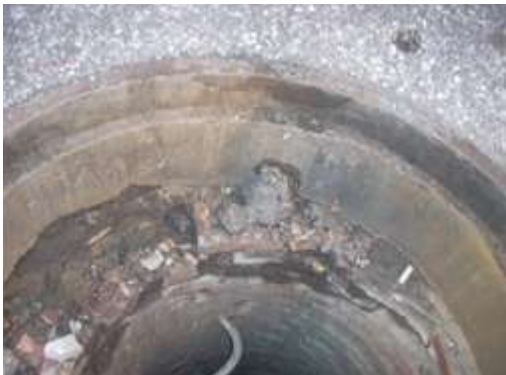
Defect 3

Condition: ☐ Sound ☐ Cracked ☐ Root Intrusion ☐ Loose Brick ☒ **Deteriorated**

CHIMNEY DETERIORATION

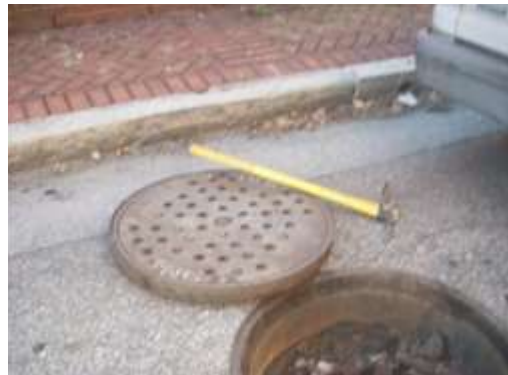
Defect 1

Type: **Stormwater**

SD LID

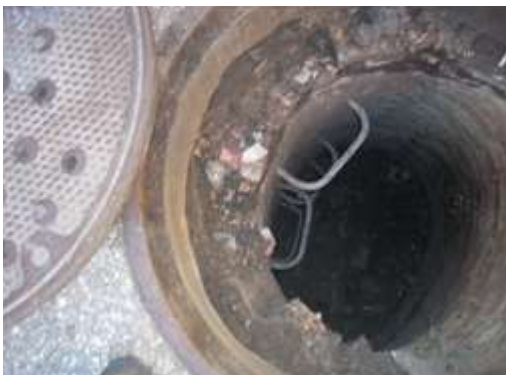
Defect 2

Offset: **6** (in.)

FRAME OFFSET

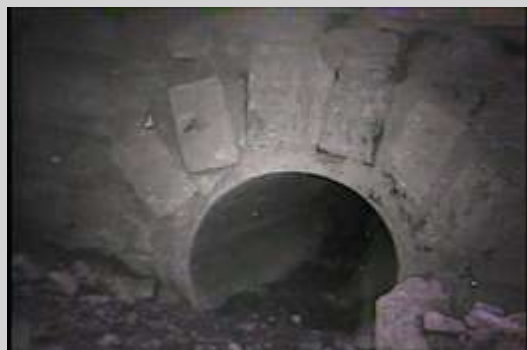
12 O'Clock Outflow

8 in. Circular Gravity Sewer
Pipe Out @ 12 O'Clock

Deposits: ☐ None ☐ Mud ☐ Sludge ☒ **Debris** ☐ Grease

Silt Depth: **1** (in.) Deposits Extent: **Light**
